Joint Task Force ONE Director of Ship Material

ARMOR AND METALLURGY PHOTOGRAPHIC INDEX

TESTS "A" AND "B"

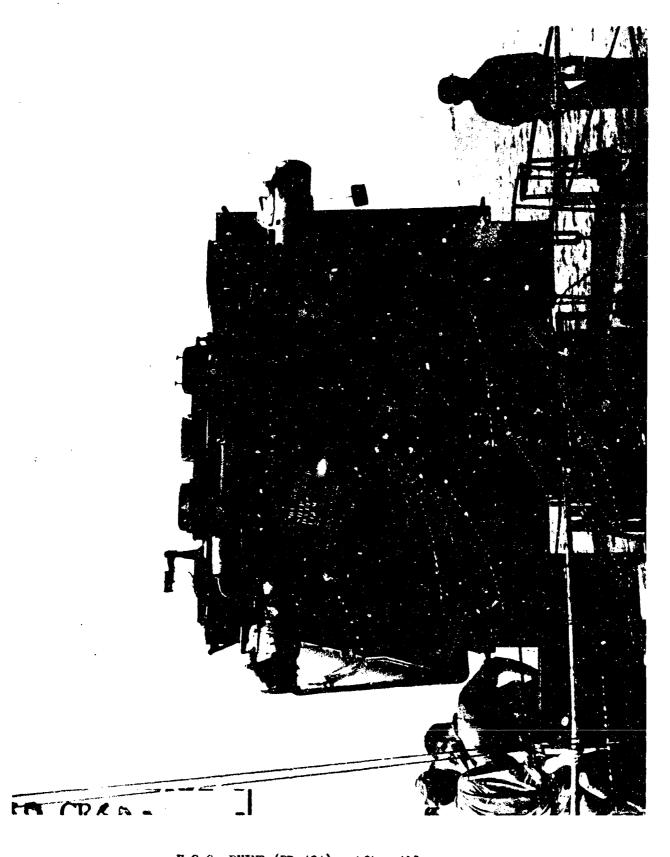
U.S.S. RHIND (DD-404) - After Able Radar Antenna, Mk. 28 (Gun Director, Mk. 33) Showing folded and torn antenna reflector and broken plastic dipole cover. Photo. No. AA-CR-60-1556-11.

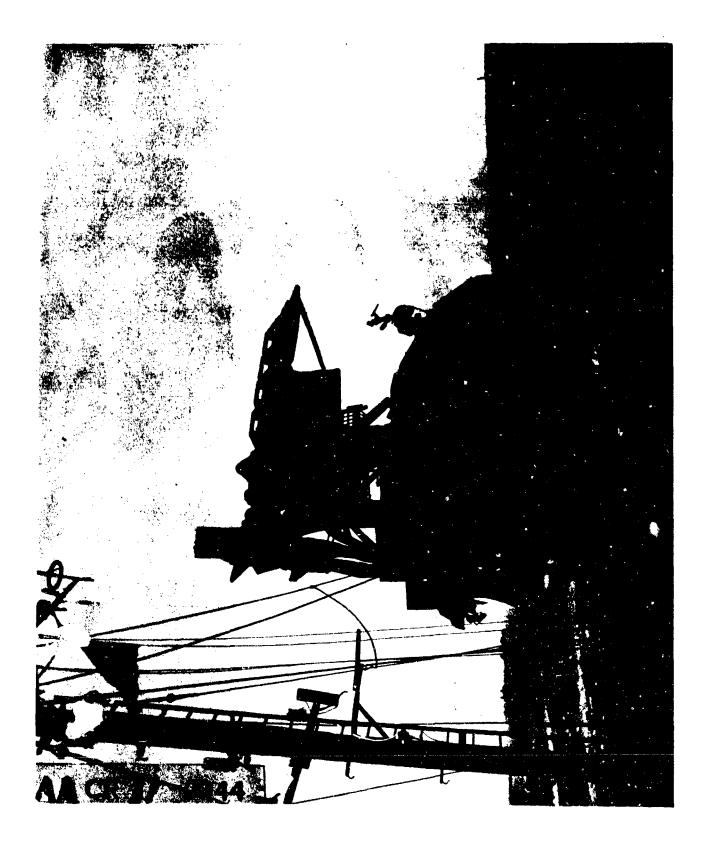
U.S.S. HUCHES (DD-410) - After Able
Fire Control Radar Equipment, Mk. 4, Mod. 0, Serial
Me. 1231, and Mk. 22, Mod. 0, Serial No. 518, located
on the Gun Director, Mk. 37, showing the bottom
semi-parabolic reflector of the Radar, Mk. 4, smashed
against the antenna mount, and the antenna of the
Radar Mk. 22, twisted about 180° from its normal position.
Photo. No. AA-CR-71-2044-7.

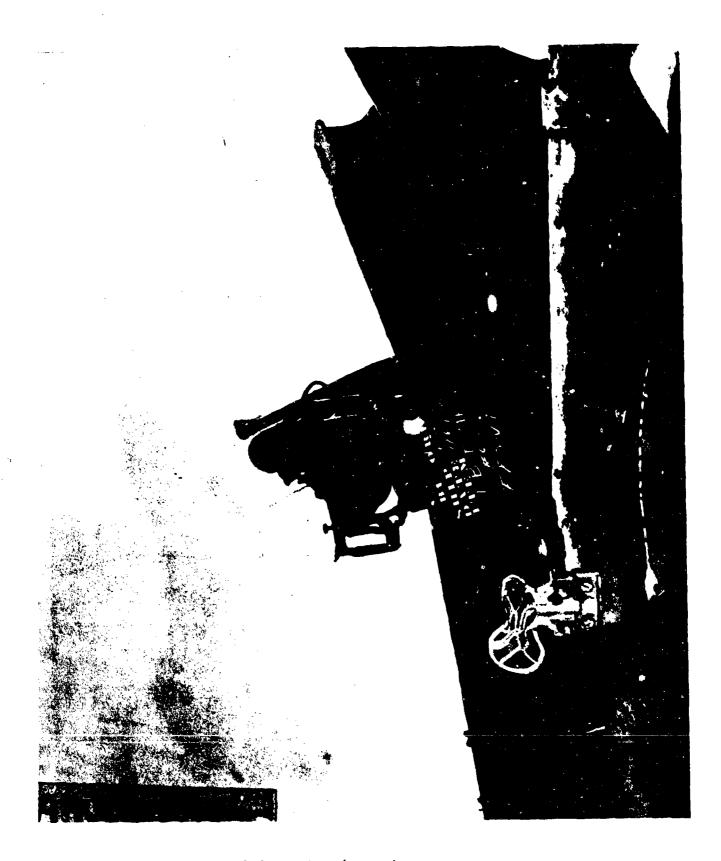
U.S.S. SKATE (SS-305) - After Able Target Bearing Transmitter, Mk. 9, Serial 62, located on the bridge. Showing a rear view of the upper assembly. Photo. No. AA-CR-79-1978-2.

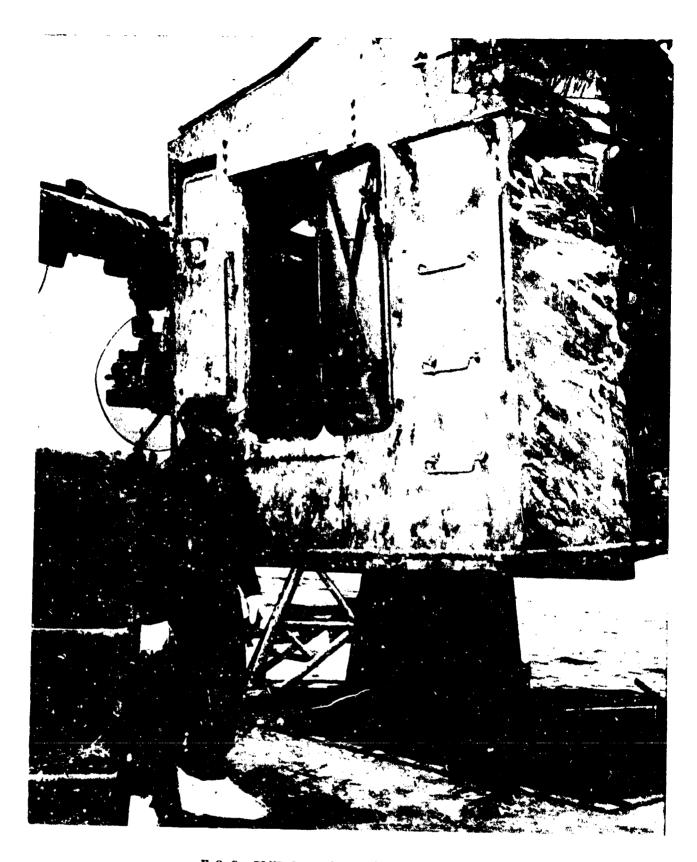
U.S.S. PENSAC LA (CA-24) - After Baker Gun Director, Mk. 33 (Aft), Shows rear of director shield dished by the blast and director tilted and off roller path. Photo. No. AB-CR 78-1683-7.

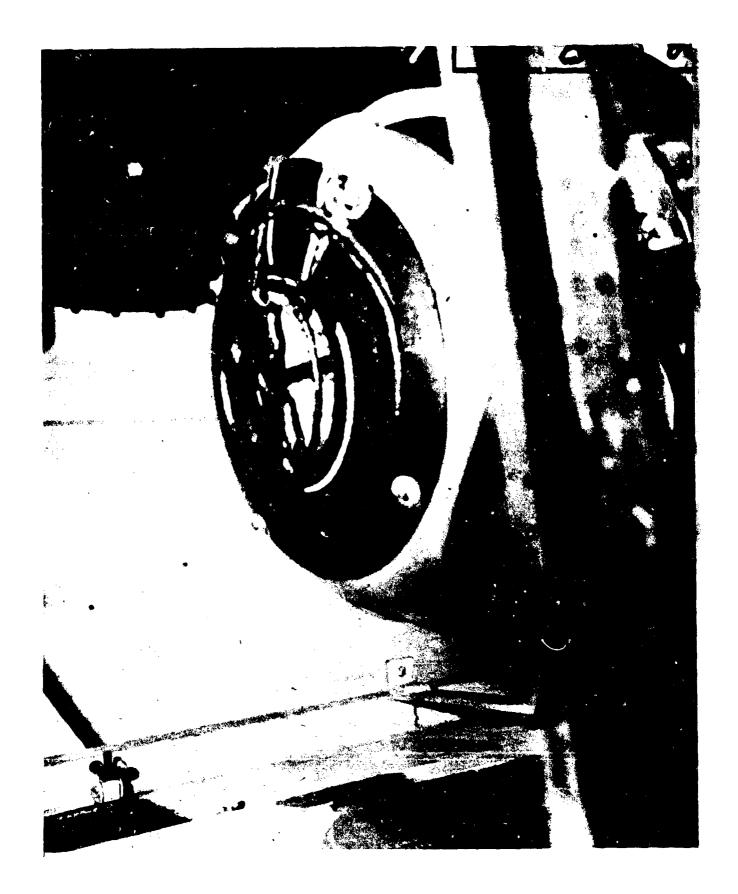
U.S.S. PENSACOLA - CA24 - After Baker Stable Element, Mark 3 (Gun Director, Mark 35 - Aft). Shows broken umbrella on Stable Element. Photo. No. ABCR 78-1715-1.

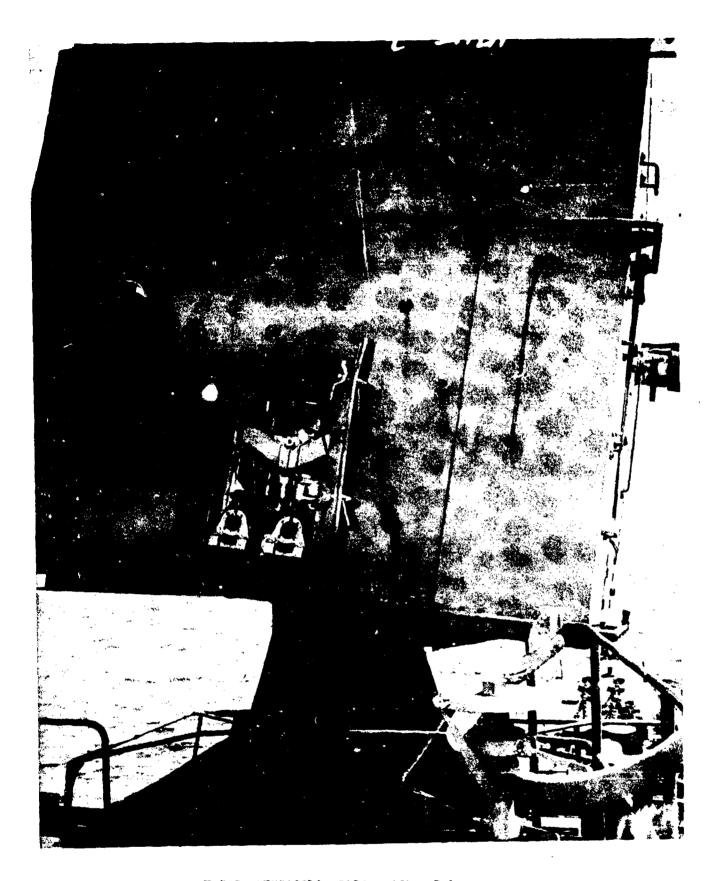
U.S.S. PENSACOLA -CA24 - After Baker Gun Director Mark 33 (Fwd). Rear view of director. Showing Director tilted on roller path. Photo. No. ABCR 78-1715-2.

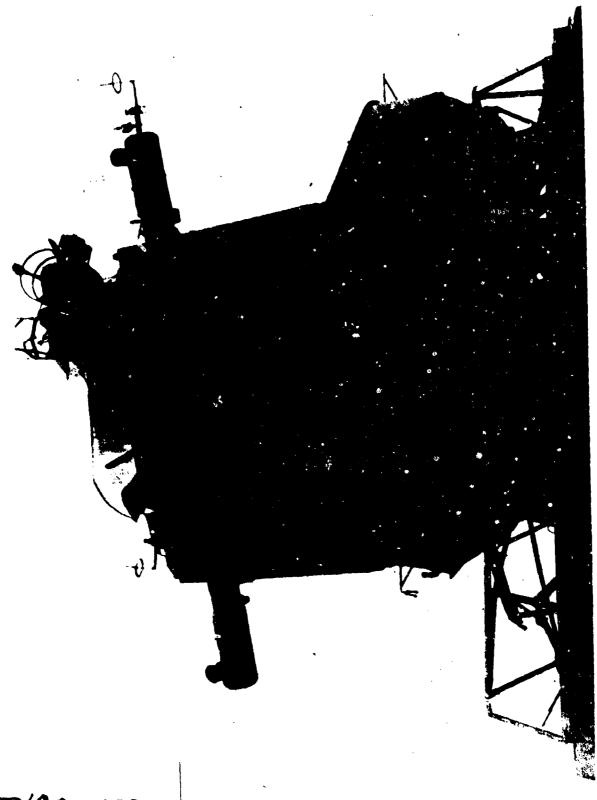
U.S.S. PENSACOLA - CA-24 - After Baker Gun Director, Mark 33 (Top of Pilot Hense Fwd.). Shows Gun Director Tilted on roller path. Photo. No. ABCR 97-1684-1.

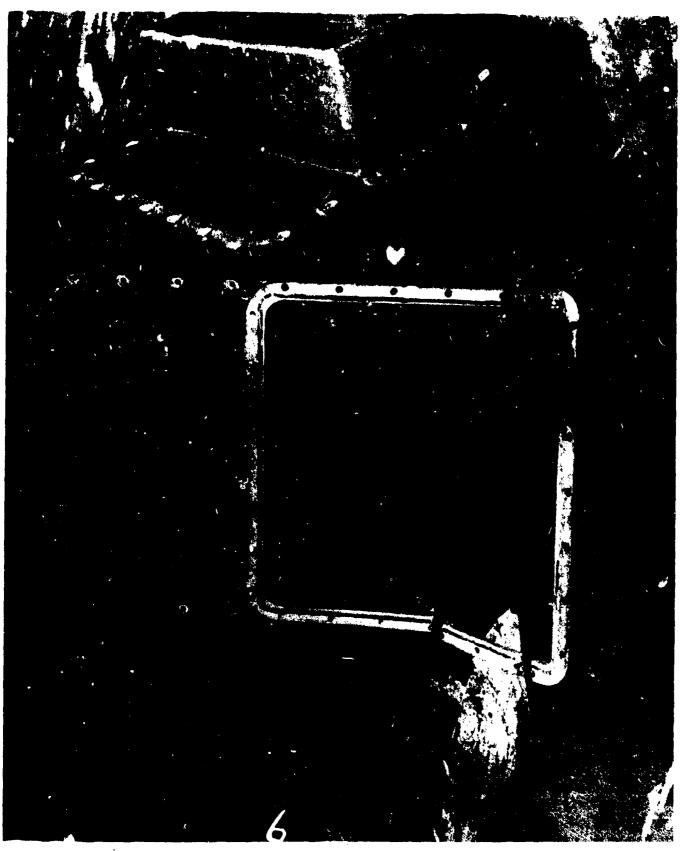
U.S.S. PENSACOLA - CA24 - After Baker Gun Director, Mark 33 (Top of Pilot House Pwc.). hear view of Director and Stable Element, Mark 2. Photo. No. ABCR 100-4203-5.

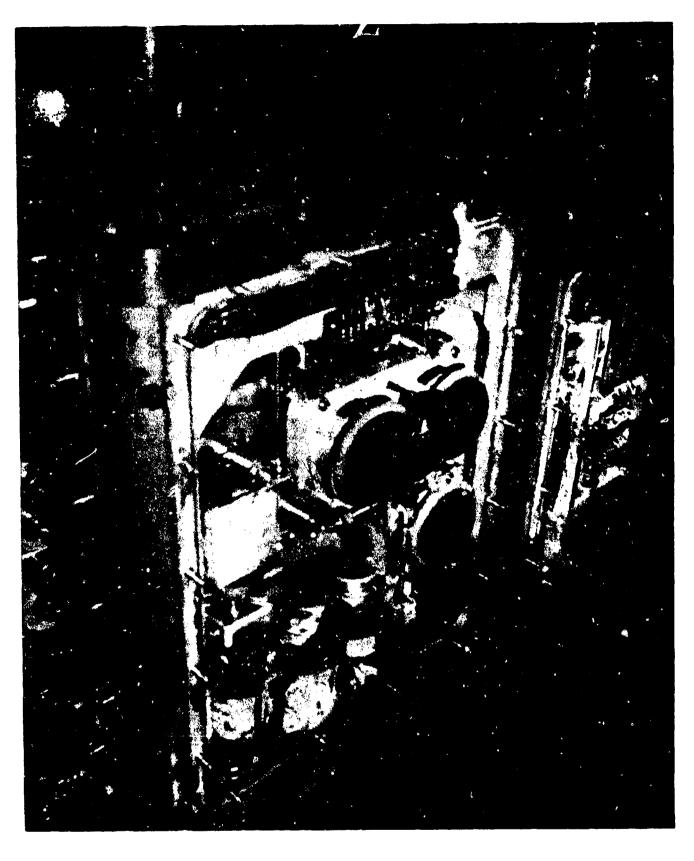
U.S.S. HUGHES (DD-410) - After Baker Gun Director, Mk. 51. Showing Gun Director with associated Gunsight, Mk. 14, missing. Photo. No. AB-CR-66-151-4.

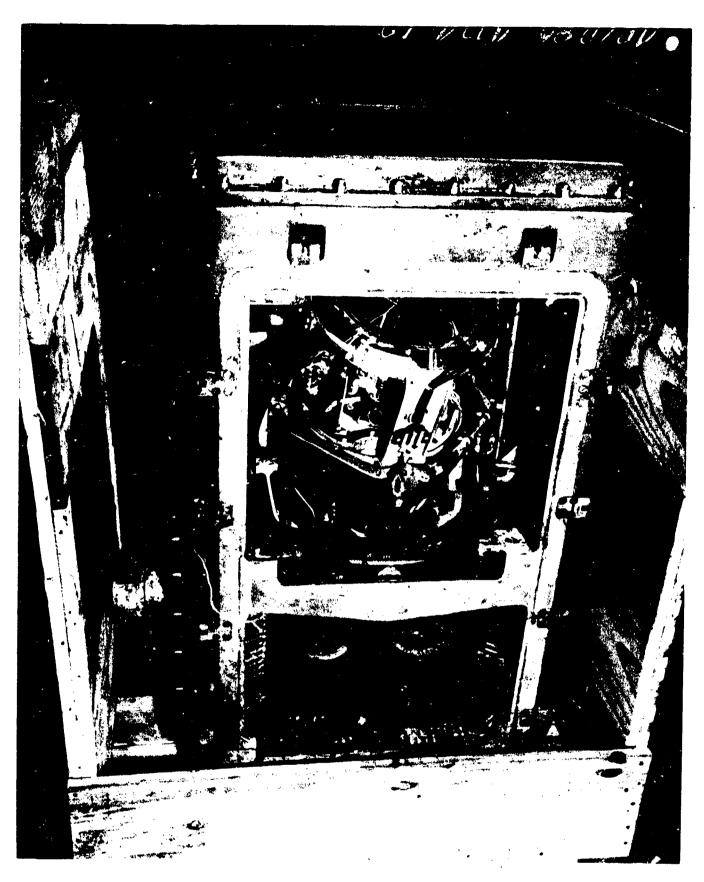
U.S.S. HUGHES (DD-410) - After Baker Stable Element, Mk. 6 (Plotting Room) Shows broken umbrella. Photo. No. AB-CR 82-4224-12.

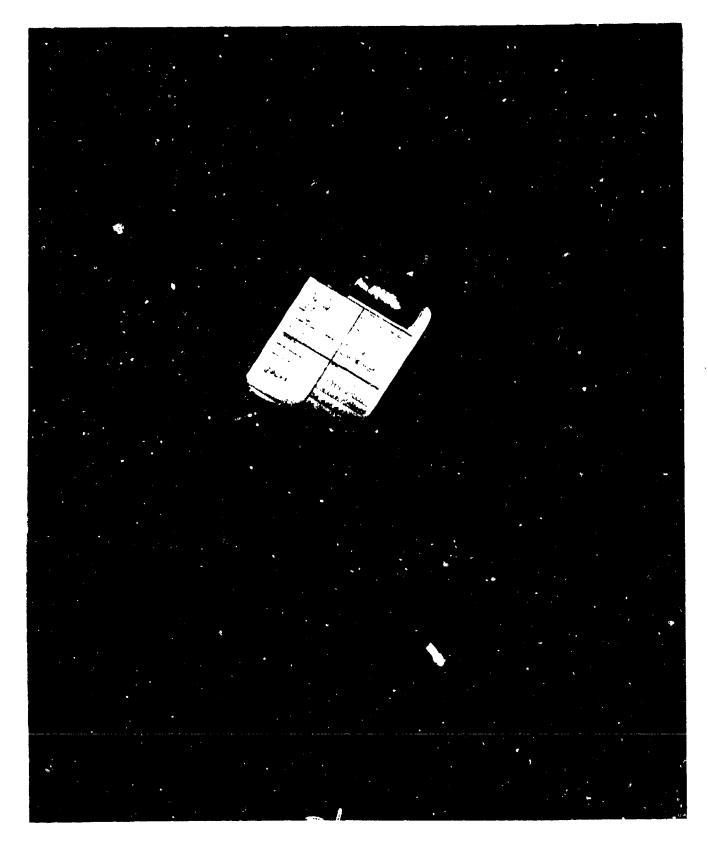
U.S.S. NEVADA (BB-36) - After Able View showing damage sustained by AN-M100A2 fuse recovered from 100 lb. bomb blown from rack of CS2U-3 airplane. Photo. No. AA-CR-73-997-1.
